# SOME FAILURE PROBLEMS IN SPACECRAFT AND SPACE BOOSTERS

**GODDARD SPACE FLIGHT CENTER**

By  
A. J. Babecki  
J. D. Grimsley  
H. E. Frankel

July 1966

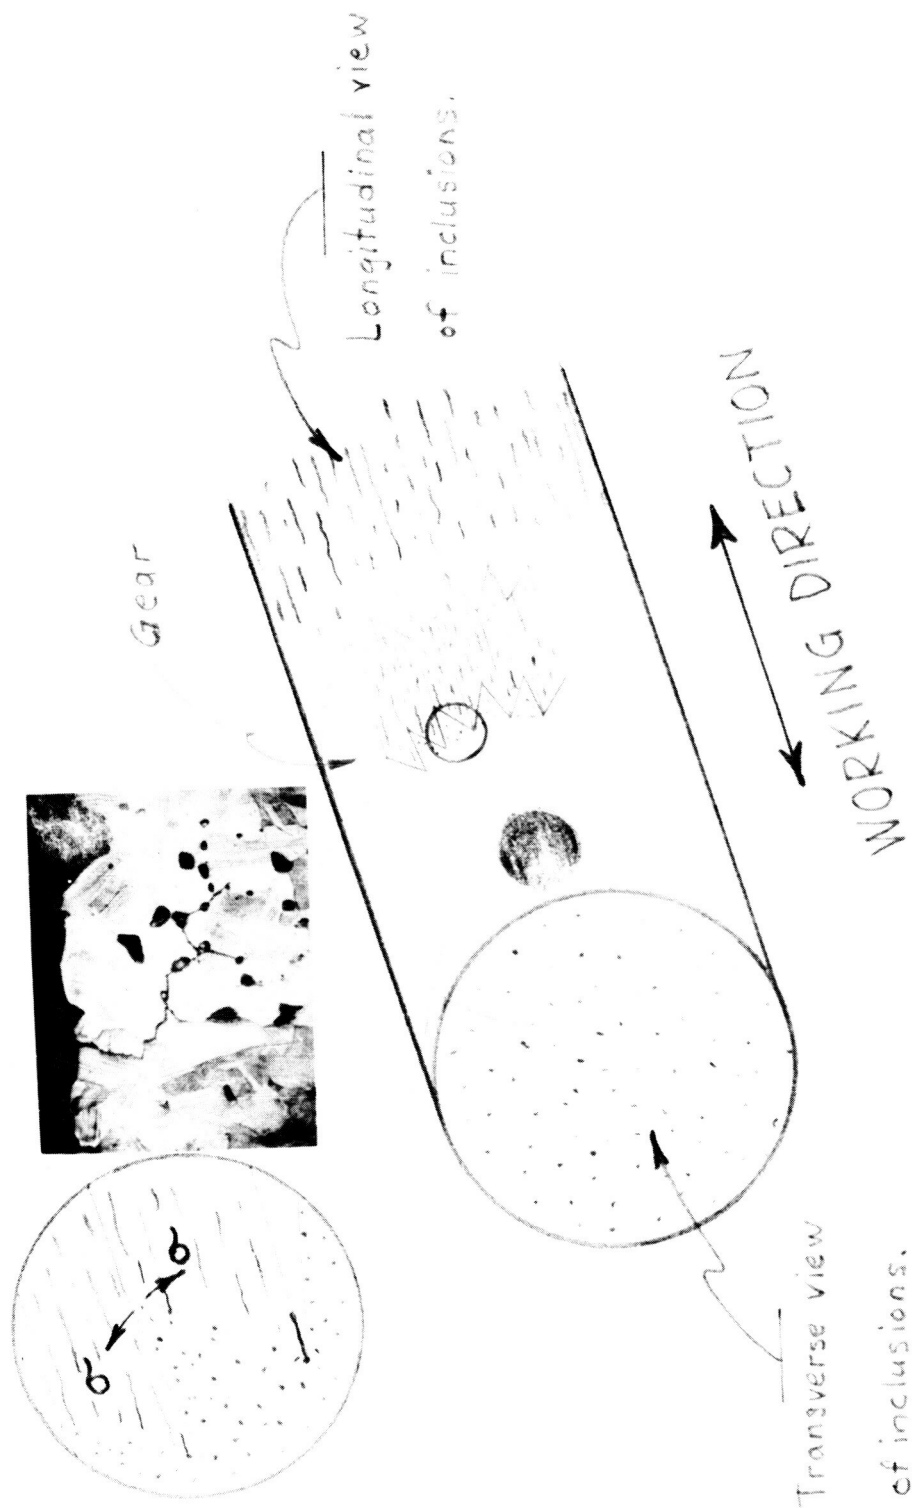
direction of the bar. This resulted in large inclusions being oriented normal to the stress direction, as shown in Figure 1, such that they served as minute stress concentrators which precipitated failure at the root of the teeth during vibration testing. The lead inclusions also significantly reduced the effective cross section of the phosphor bronze.

Figure 1. Schematic representation of inclusions in wrought bar stock and manner in which they may cause premature failure in gears. Photo insert shows cracking in the root of a gear tooth propagating between inclusions. Transverse section at 500X. Ferric chloride etch.

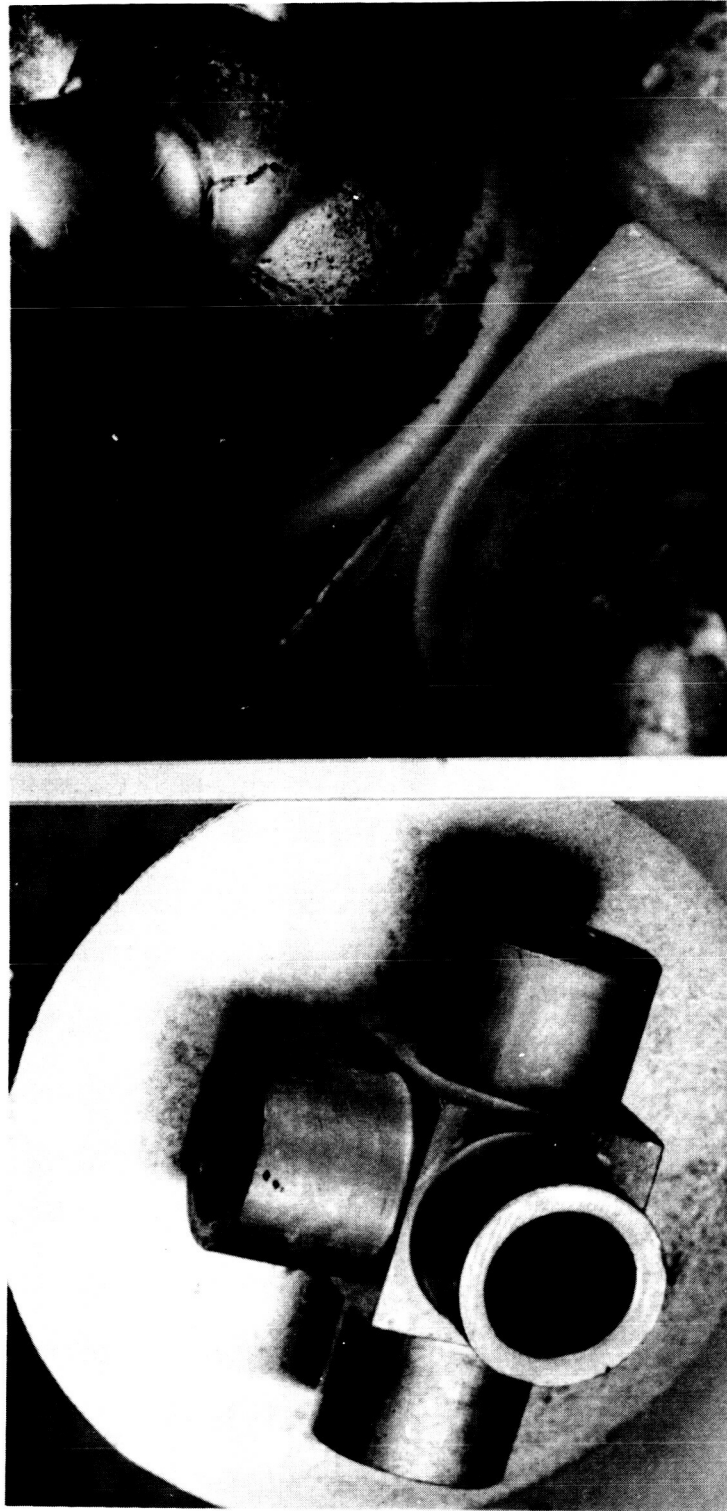
A typical fitting is shown in Figure 2 against the cross section of the extruded 1-1/2" diameter bar from which it was machined. One of the fitting legs is also pictured at higher magnification to reveal the appearance of a leak (encircled) that was approximately two mils in diameter. In all cases, the holes developed in a direction parallel to the longitudinal direction of the extruded bar.

Figure 2. Fitting for concentrated  $H_2O_2$  service machined from 1060 aluminum extruded bar stock. Orientation of fitting in bar cross section is shown at left; close-up view of leaking corrosion hole (encircled) is pictured at right.

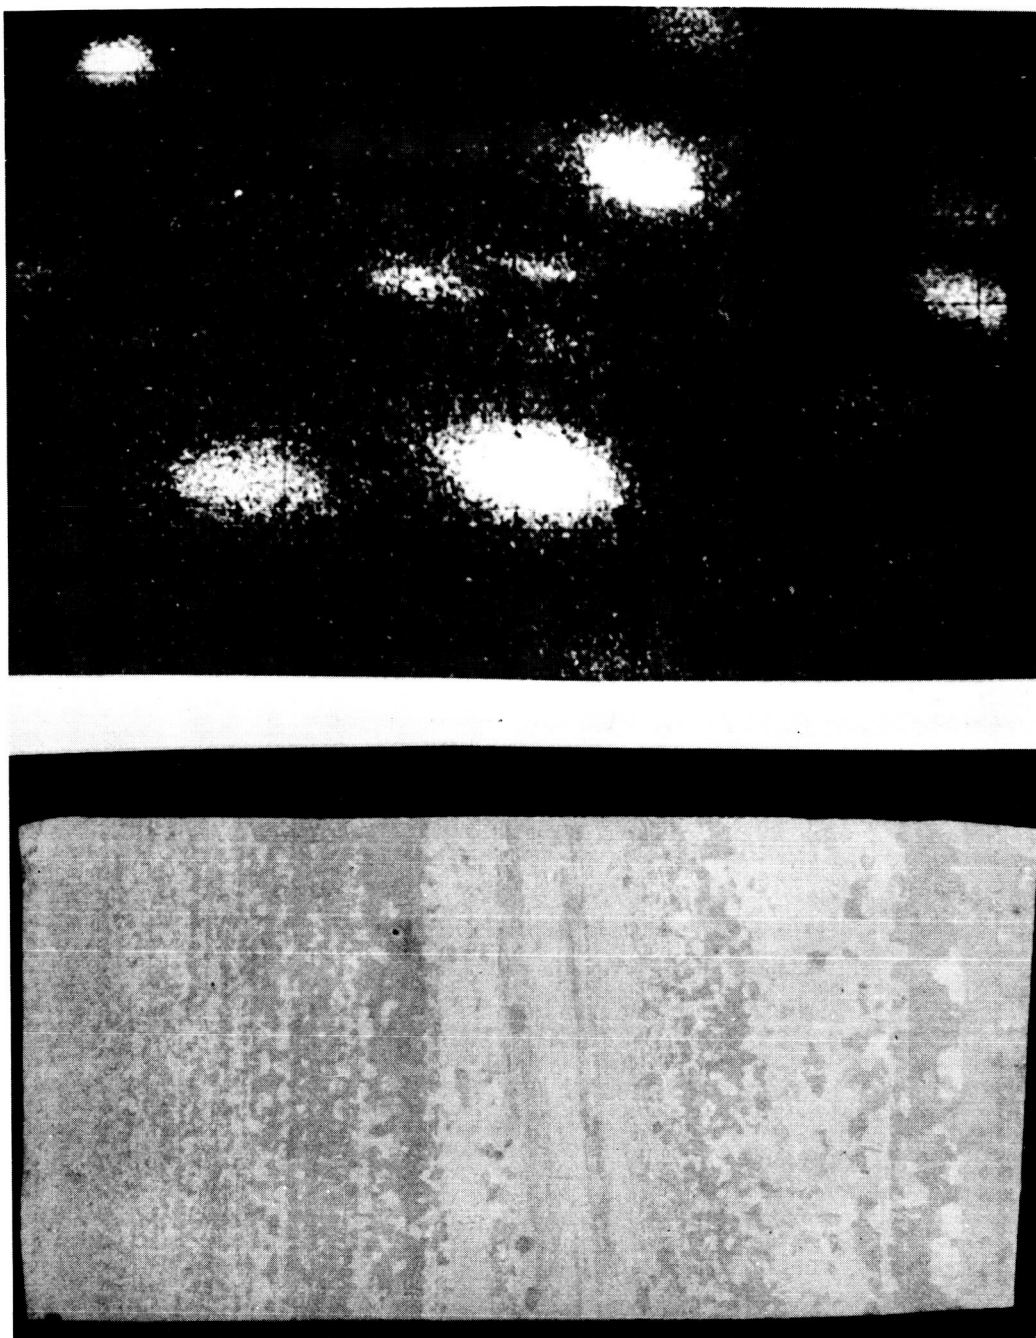
Figure 3 pictures a radius cross section of the bar after polishing and chemical etching. The elongated flow pattern of the structure is evident as well as the refined grain size at the outer surface caused by some subsequent cold working. As the alloy is quite pure, the inclusion rate was quite low, and no stringer formation could be noted. Accordingly, the etching out of inclusions could not be the reason for the hole development.

Electron microprobe scans were made on the longitudinal and transverse cross sections for the more common trace elements, iron, copper, silicon, and manganese. Only iron was detected as being concentrated at spots that measured 0.2 - 0.3 mil in diameter, and the iron concentrations at these spots were as high as 35%. Some of these high-iron spots occurred in clusters, as seen in the transverse section of Figure 3. In the longitudinal section, these spots are greatly elongated and could serve as paths of leaching by the acid and peroxide.

Figure 3. Longitudinal plane through a radius cross section of the 1060 aluminum bar after exposure to hot 70%  $\text{HNO}_3$  (left). X-ray image at 1775X of iron concentrations (bright spots) in transverse cross section of bar, on right, made by electron probe microanalyzer.

This possibility seemed to be confirmed by subsequent tests in which thin transverse slices of the bar were subjected to annealing treatments at 1100°F for 1 and 16 hours. Following each of these treatments, which permitted diffusion to minimize the iron concentrations, the populations of the corrosion pits that developed were successively and significantly less. The 1 hour exposure about halved the population and the 16 hour exposure reduced it by about an order of magnitude.

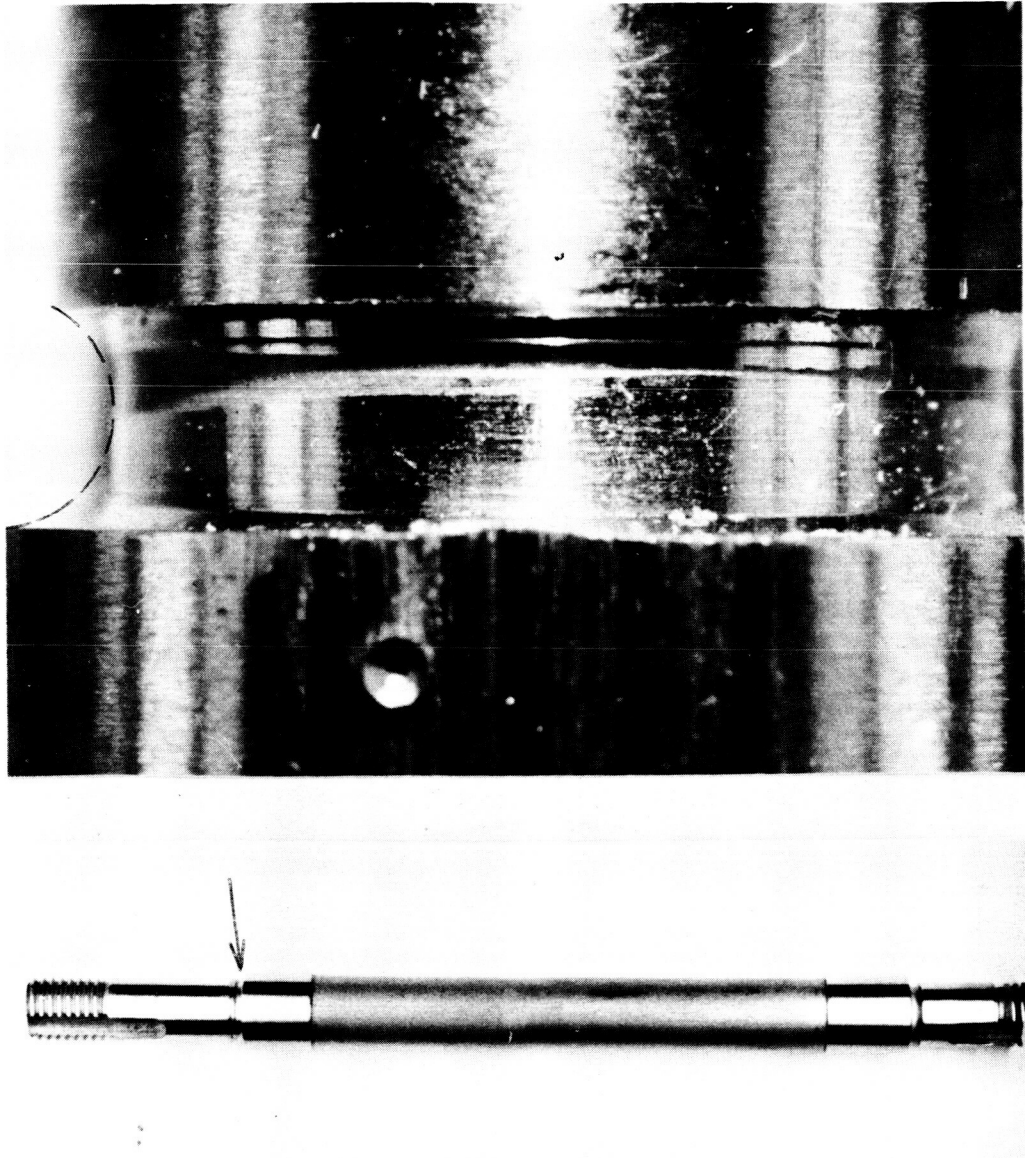
A typical shaft is shown in Figure 4. The failure occurred at the 0.270" diameter relief undercut adjacent to the upper shoulder. Although the drawing for this shaft called for a 20-mil radius to the undercut, many were found with radii of less than 10 mils. A sample of such an undercut is also pictured in Figure 4. The width of the undercut is 40 mils; therefore, it should exhibit a smooth, fully-concave surface.

Figure 4. Tape recorder reel shaft (left) with failure location indicated by arrow. Enlarged view of undercut area (right) with specified radius shown by dashed line.

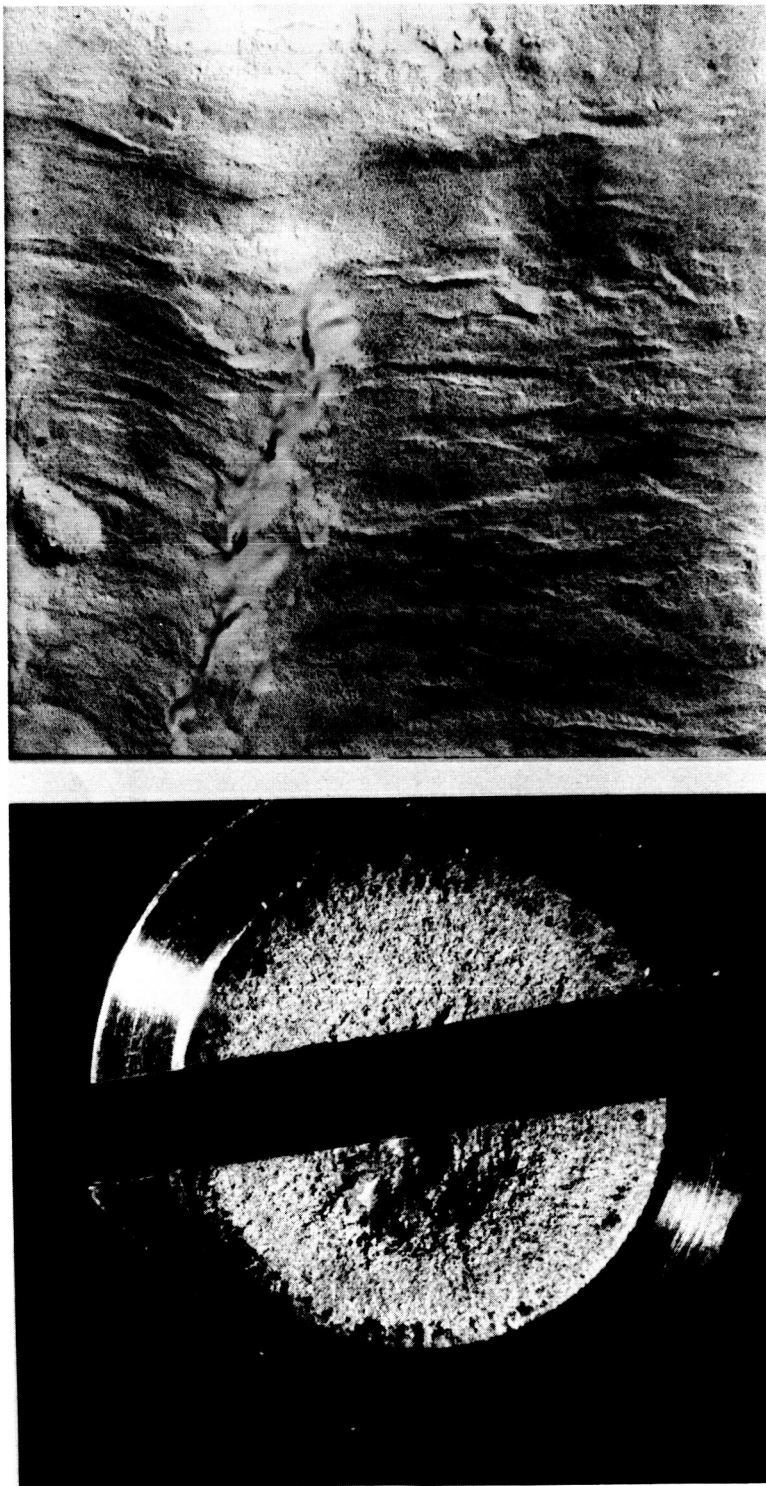
Initial failure analysis by the contractor termed it a brittle failure caused by impact during vibration. Subsequent analysis by the authors termed it a fatigue failure due mainly to the stress concentrating effect of the 6 mil radius measured in the undercut notch. A macroscopic view of the fracture surface shown in Figure 5, gives faint hints of concentric rings to indicate fatigue crack propagation. However, fractographs made by the electron microscope at 16,000X, also shown, definitely revealed the parallel striations typical of fatigue failures.

Although the 416 stainless steel exhibited a large amount of free ferrite in its microstructure and large sulfide inclusions, which improve machinability, these factors were not as contributory to the failure as the poor machining practiced.

Figure 5. Macrograph of fracture face of tape recorder shaft at 12X (left) and electron fractograph of typical area on fracture face at 16,000X (right) both indicate fracture by fatigue crack propagation.

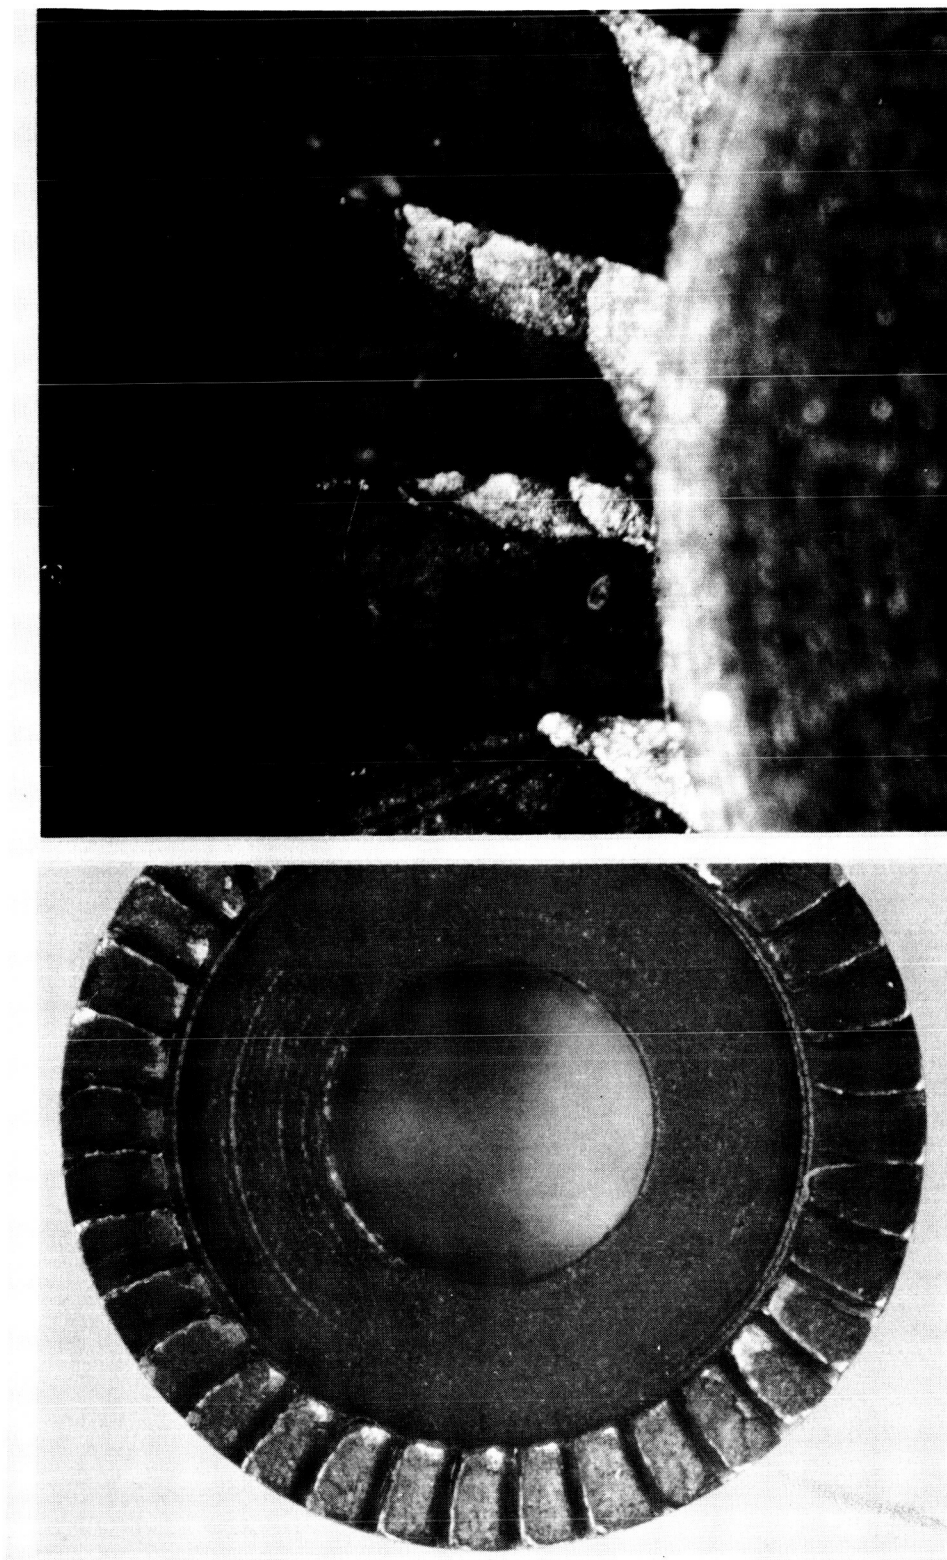
Figure 6 illustrates one such application. This is a ratchet wheel which was part of a driving mechanism for a spectrometer grating. It measured only 1/4" in diameter and had teeth that were only 11 mils in slant height. It was made of Nitralloy 135M. and had a mating pawl of C 1095 steel hardened to 50 Rc. Although the contractor was to use gold plating and molybdenum disulphide as solid lubricants on the ratchet wheel, nitriding of the wheel to minimize cold welding was also practiced.

As shown in the photograph, this procedure produced extremely brittle teeth which were subject to early failure in operation, and even during handling in assembly. Figure 7 presents etched transverse cross sections of broken and nonbroken teeth at 200X and 375X respectively, which indicate that instead of a thin nitrided surface, the process produced complete hardening of the tooth volume. Micro-hardness measurements disclosed that a hardness of 65 Rc was obtained to a depth of 7 mils, which was more than half the slant height of the ratchet tooth.

Figure 6. Ratchet wheel (left) from spectrometer grating drive which suffered chipping of nitrided teeth, as shown at higher magnification (right).

A change of material for the ratchet wheel to an air or oil hardening steel, such as 4340, eliminated the problem, and although the surface hardness was reduced from 70 Rc to 55 Rc, it was found to be adequate to prevent galling or cold welding.

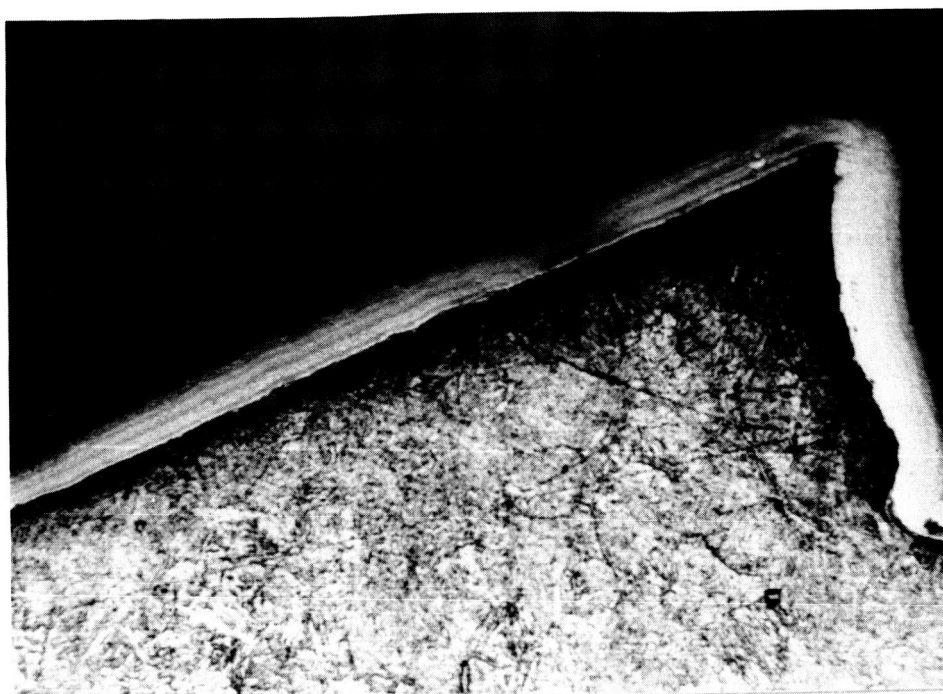
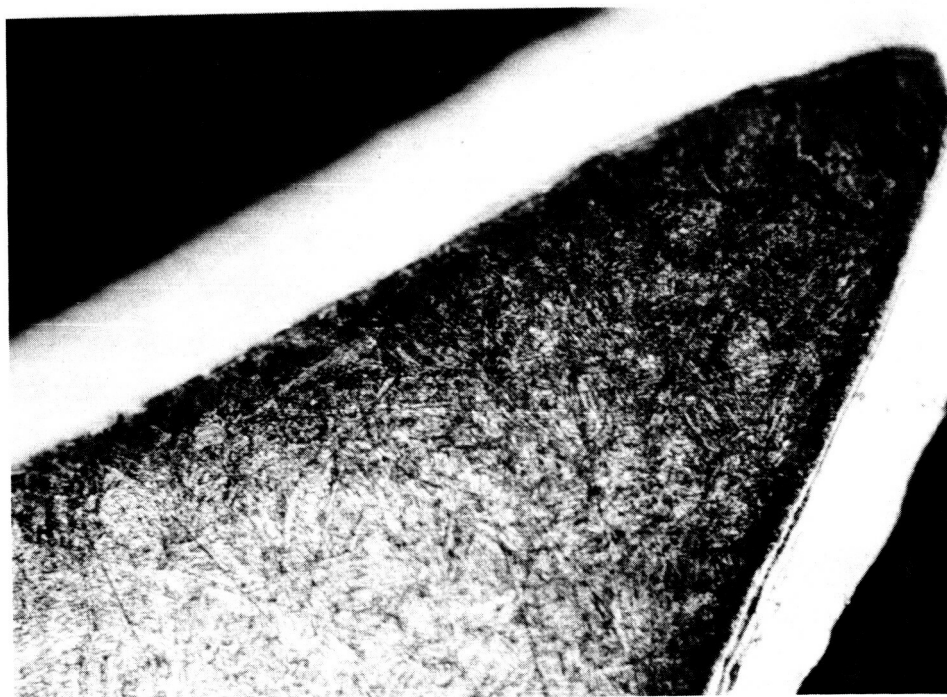
In addition to the highly embrittling effect, the nitriding process also placed the surface material in compression, which normally is a desirable condition. But on external angles, such as the ratchet or gear teeth, this high compressive stress places the subsurface volume in tension and produces the tendency for spalling or cracking. This residual stress, coupled with the service stresses, was sufficient to cause the breakage noted.

Figure 7. Transverse section through chipped ratchet tooth (top) at 200X and through nonbroken area (bottom) at 375X. Depth of nitriding revealed by nital-etched dark area.

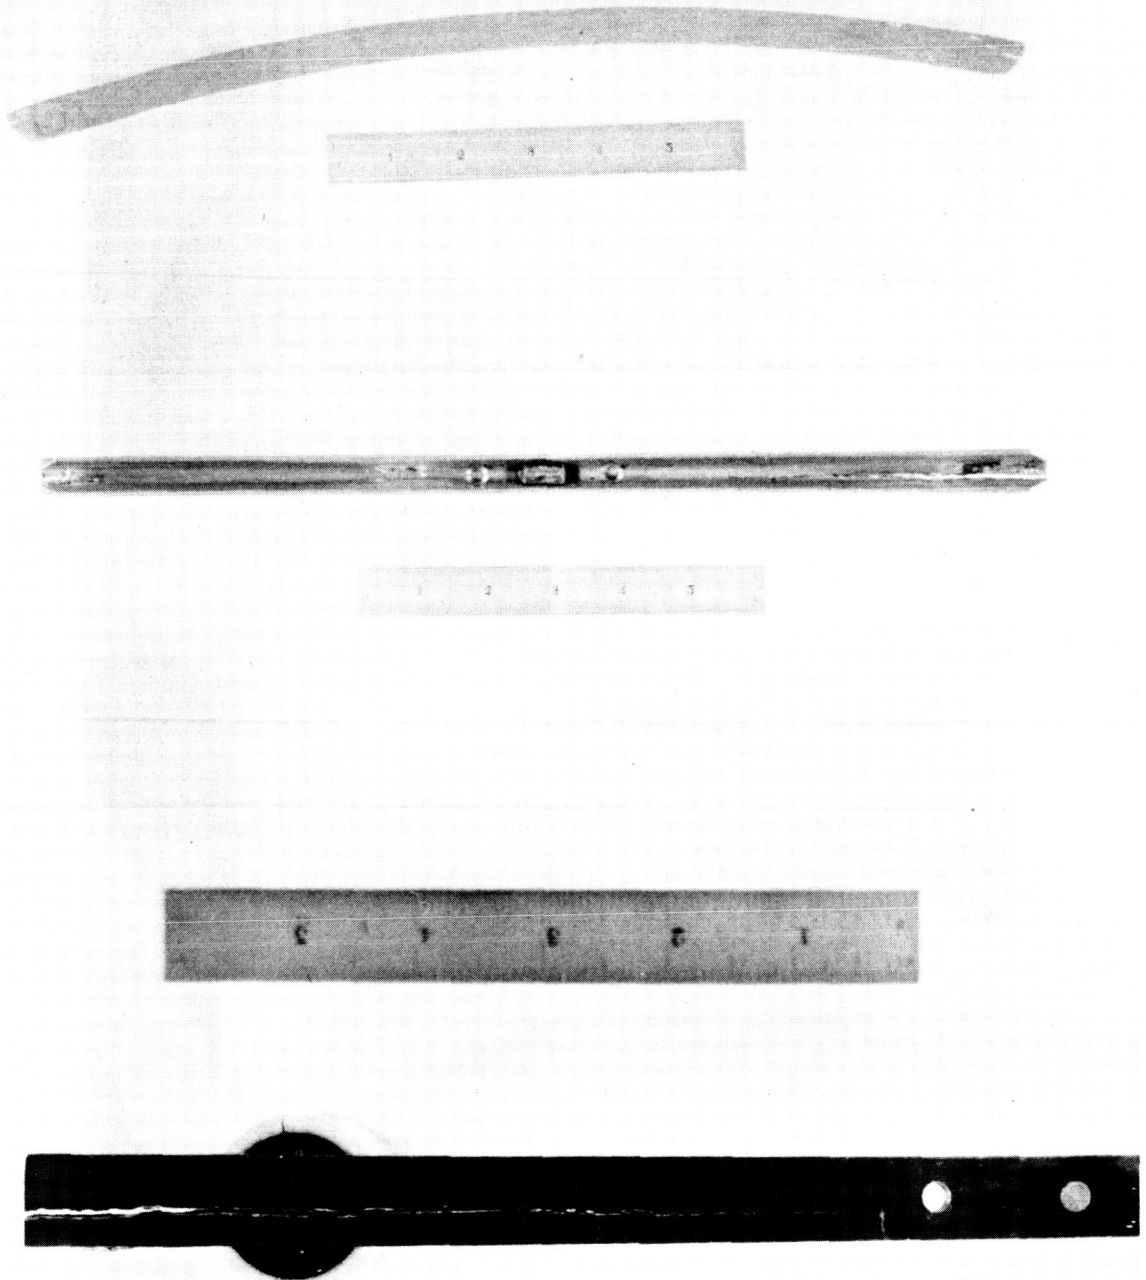
Figure 8 shows three views of one such cracked shoe. In all failures of these shoes, the crack originated at an end. An important element in these failures is the fact that the ring forging from which the shoes were cut had a smaller radius than that of the flanges which they held together. Accordingly, in this Marman-type band, the shoes were stressed mainly at their ends where existing corners and machining marks aggravated the stress situation. The thickness of the web at the base of the U was 0.20" and the radius of the U corners was 0.080". In other words, the alloy was being stressed in its short transverse direction by a wedge action which concentrated the stresses at the 80 mil corners.

Figure 8. Three views of 2014-T652 aluminum shoe from spacecraft separation band with crack progressing from end.

could account for the bands. It is assumed that they represent varying dislocation densities, such as the flow lines in forged steel. Proposed solutions to the problem included a change in radius of the forged ring to one slightly larger than the flanges so as to load the center of the shoes rather than the edges, and a change in forging practice so as to forge the ring into a rough U cross section.

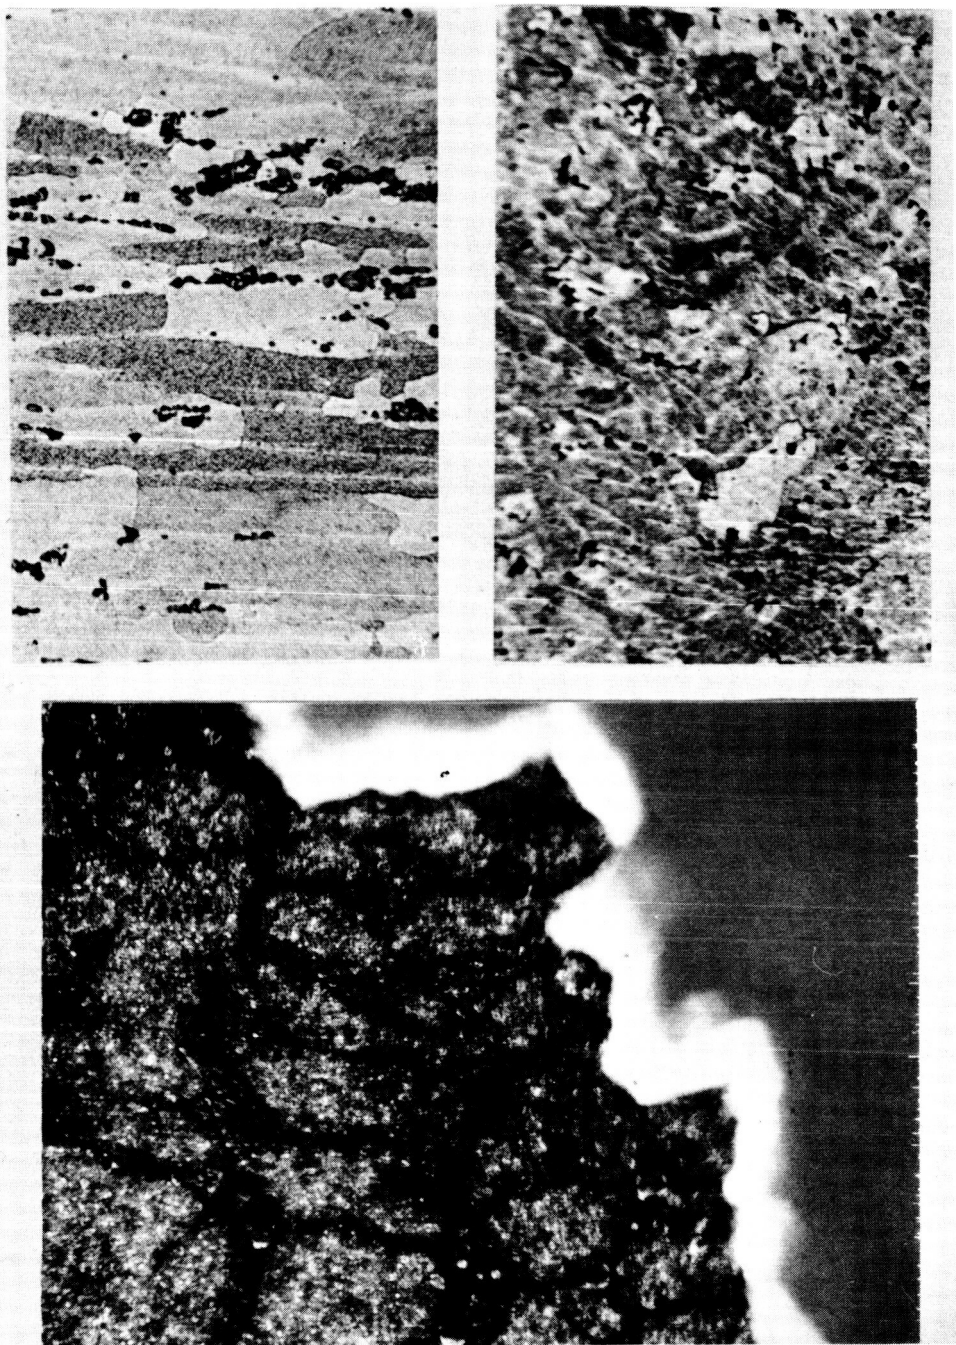
Figure 9 presents photomicrographs of the longitudinal and transverse sections in direct light at 150X and 100X, respectively, and the transverse section adjacent to the crack under polarized light at 500X. The longitudinal section delineates the grain boundaries clearly; however, the transverse section reveals a cellular structure, especially under the polarized light. It is noted that the crack predominantly follows along the cellular paths. Figure 10 indicates that these cell boundaries, or bands, are more brittle than the material within them. This accounts for the difference in ductility exhibited by the alloy between the longitudinal and transverse directions, viz. 10% vs 2%. Electron microprobe examination did not disclose any compositional heterogeneity which

Figure 9. Longitudinal and transverse views of 2014-T652 aluminum shoe (top, left and right) at 150X and 100X, respectively. Light bands outline cellular structure which is elongated in longitudinal direction. Under polarized light at 500X, cellular structure in transverse plane (bottom) is outlined by dark bands.

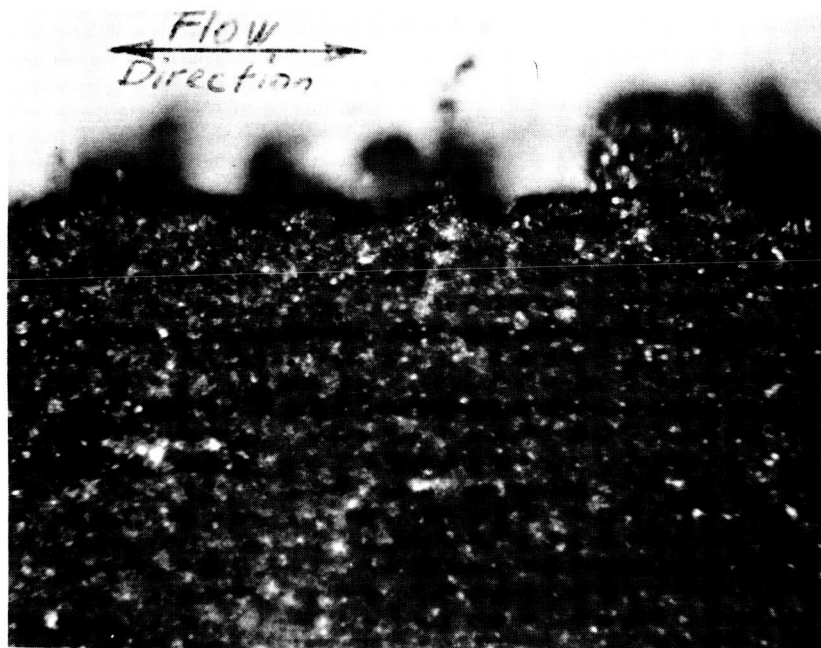
Figure 10. Elongated cellular structure in longitudinal plane along fracture edge under polarized light showing evidence of ductility transverse to the cellular bands (top) and a lack of ductility parallel to the bands (bottom). Magnification 375X. HF-H<sub>2</sub>O etch.

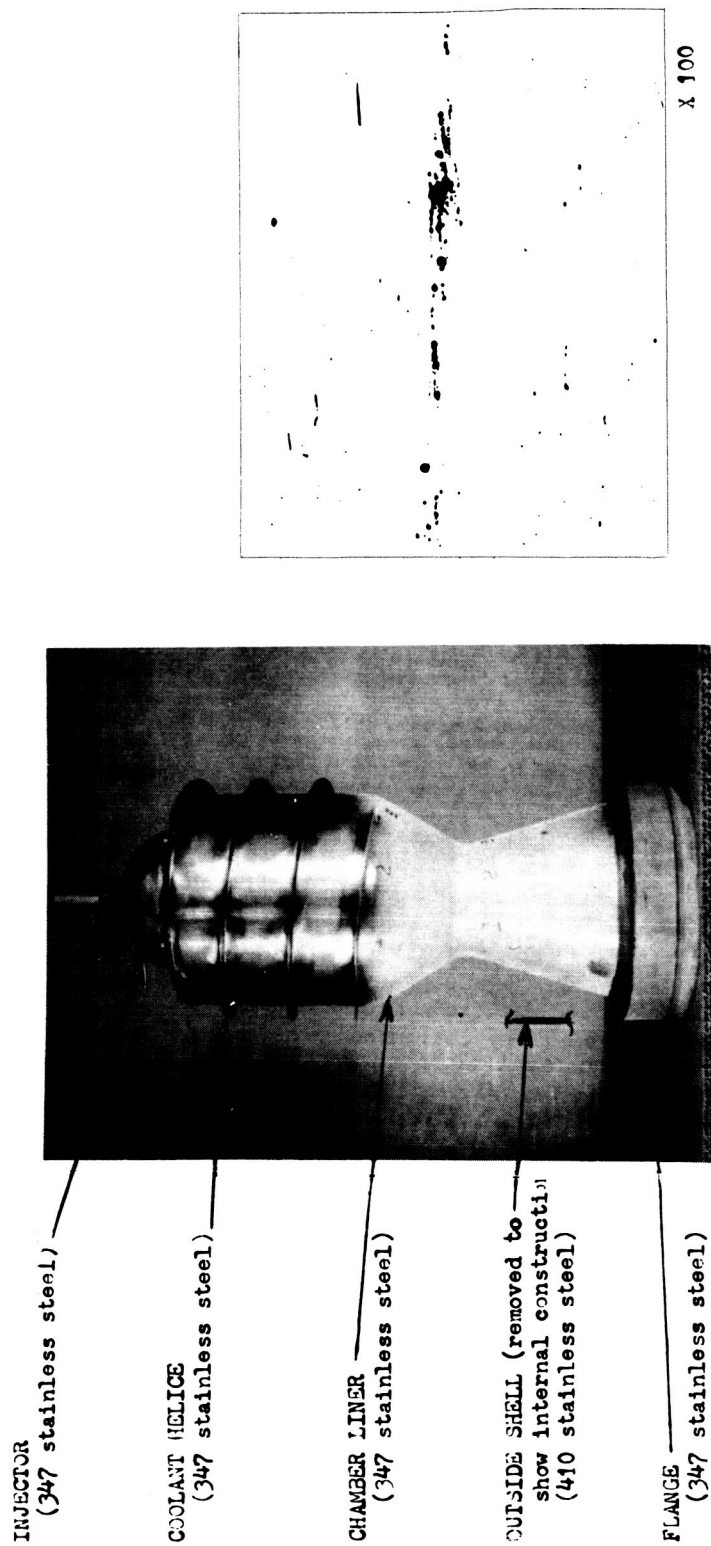
Thrust chambers for the Aerobee rocket sustainer stage are of double-wall construction which are cooled during firing by the flow of fuel between the walls. Figure 11 shows such a thrust chamber with the outer wall of 410 stainless steel removed. The inner wall is machined from a forging of 347 stainless steel to give the proper nozzle contour.

Inasmuch as the liquid fuel coolant circulates between the walls under a positive pressure before being injected into the combustion chamber, the construction must be leak-tight. A problem arose when a number of completed thrust chambers failed a leak test. Metallographic investigation of the failures disclosed that the 347 stainless steel chambers

were machined from an exceptionally dirty heat of steel which actually should have been rejected at the forging stage. Associated with the non-metallic stringer inclusions were voids which caused the leakage. An example of the stringer inclusions is shown in Figure 11.

Figure 11. Aerobee rocket thruster with outer shell removed. Leakage through inner shell wall was caused by inclusion stringers such as that shown.

It was learned that the forgings received only a 25% inspection rather than the 100% called for. To correct this problem, the vendor was required to conduct 100% ultrasonic and dye-penetrant inspection on all forgings as well as macrographic examination of both ends of each forging billet.

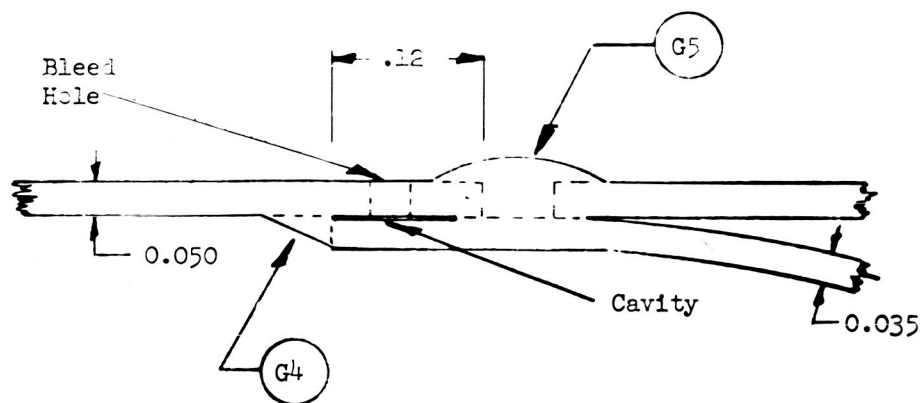
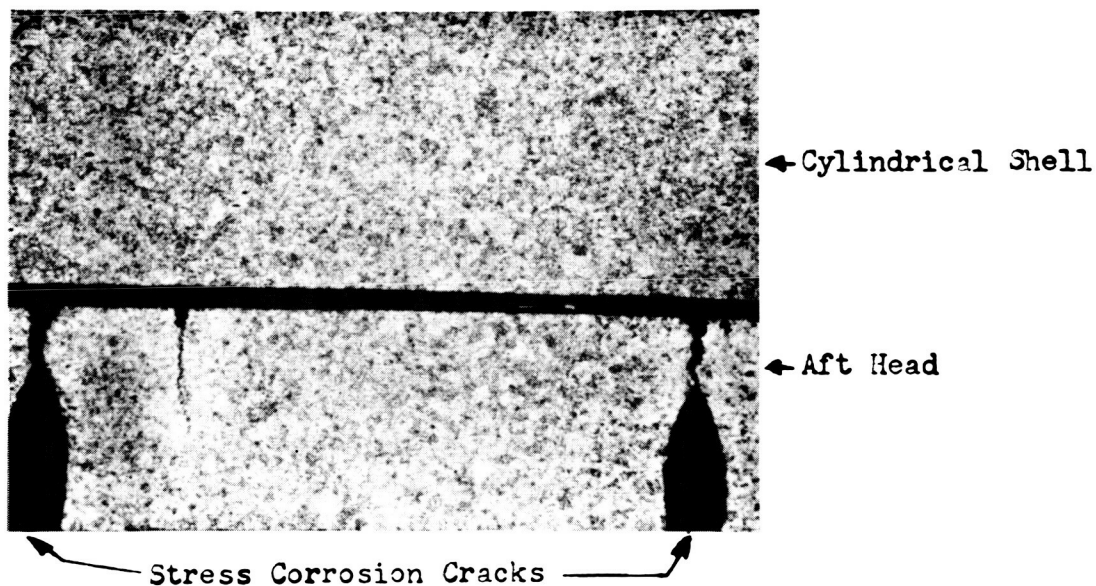
AFT HEAD TO CYLINDRICAL SHELL WELD CONFIGURATION

During leak testing of some Aerobee type 410 combination fuel-oxidizer tanks, leakage was noted in the region of the hemispherical head-to-shell weld, shown in cross section in Figure 12. This was found to be the result of stress corrosion as a result of faulty processing.

During fabrication, the head was fillet welded to the inside of the cylindrical shell about 1/8" from the shell end, which had a series of small diameter holes to serve as weep holes during final welding. In the final welding step, the remaining cylindrical shell was welded to the head and shell assembly, as indicated in the sketch. Heat treatment followed welding, and an acid pickling and descaling treatment was used to remove heat treatment scale.

Metallographic examination of trepanned samples from the suspect area revealed the stress corrosion cracking seen in Figure 12. Cause of the cracking was attributed to the entrance of acid into the faying surface cavity through the weep holes during the pickling operation and the failure to remove all of the acid during subsequent washings. The corrective action here consisted of sealing the weep holes prior to the acid exposure.

Figure 12. Geometry of head-to-shell weld joints (top) in type 410 stainless steel Aerobee rocket sustainer, and typical stress corrosion cracks (bottom) developed in the head.

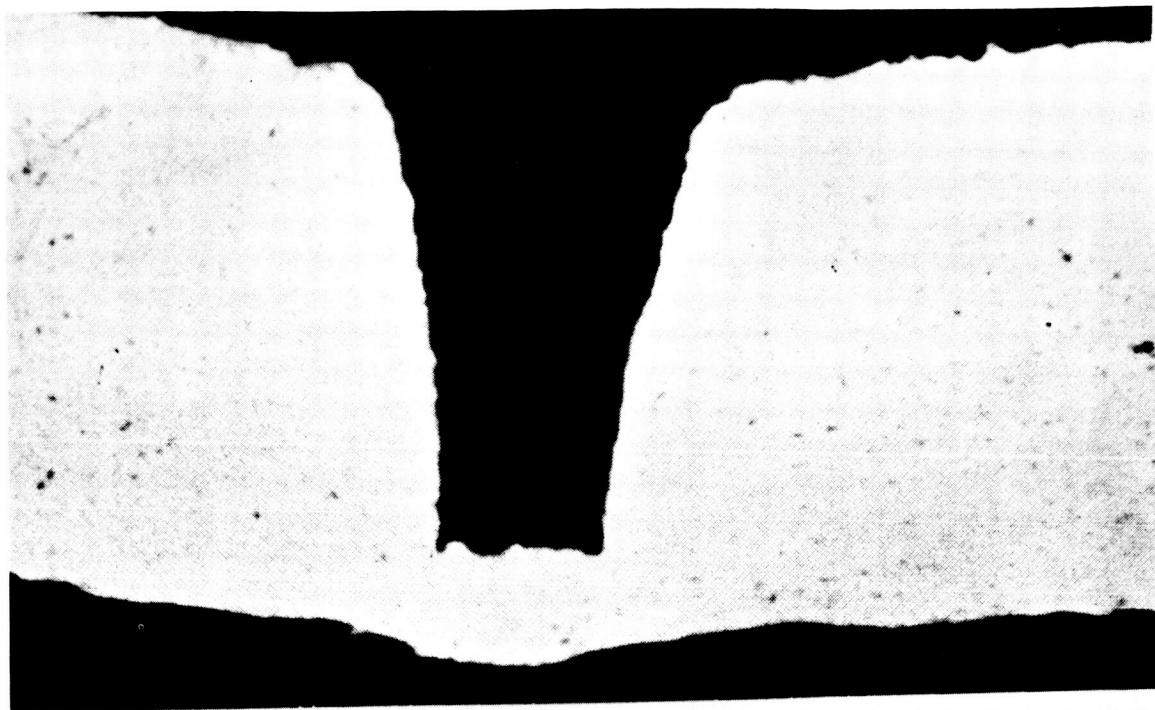
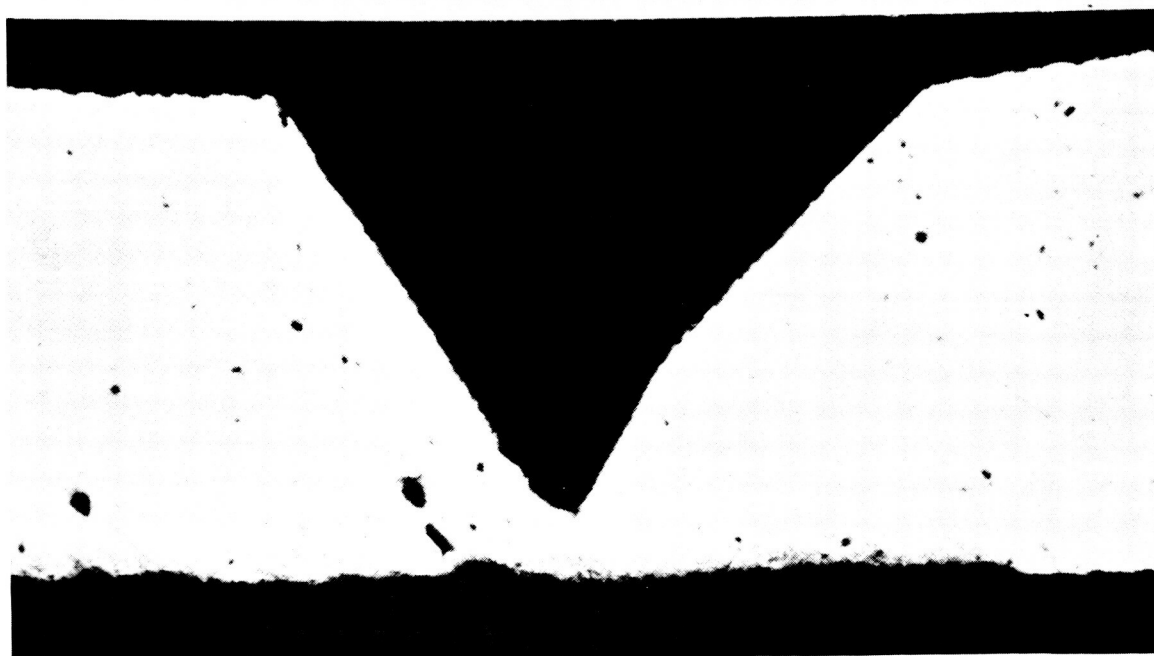
The diaphragms are made from 20 mil sheet of 3003 aluminum in the H14 temper. Bursting strength is controlled by the depth of a V-shaped circular groove which is coined into the aluminum sheets. The non-reproducible performance of the diaphragms was traced to variations in the depth and contour of the embossed V grooves. Figure 13 illustrates the kind of variations which were obtained.

Figure 13. Outlines of coined grooves in 3003-H14 aluminum diaphragms show wide variation in reproducibility.

The problem of this defective fabrication was further compounded by ineffective or lax inspection. Rectifying procedures called for closer control over the coining die contour and over the operation and better inspection immediately following the coining step.
